Results of a controlled experiment: *Home Water Plant* prevention of limescale

by Sharon Laska, Principal Investigator and Scott Borough, Researcher

Protocol for Documenting Formation and Prevention of Limescale in Hot Water Heaters Exposed to Moderately Hard Water

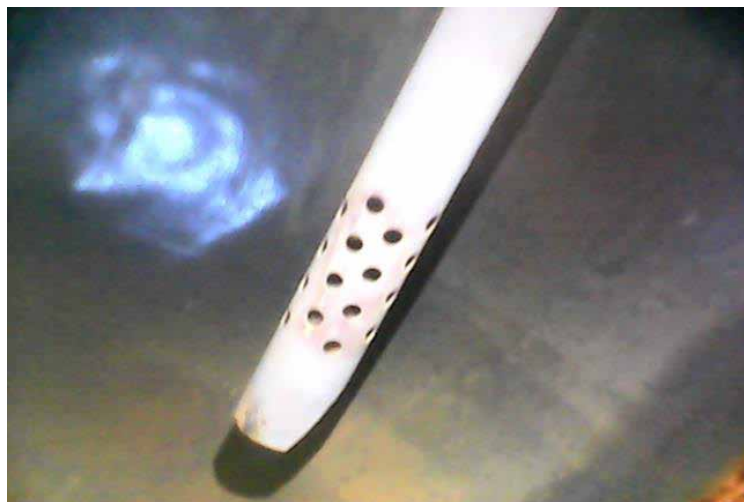
Water Supply Tube inside Hot Water Heater # 1

NO DESCALER

A white limescale crust completely covers the water supply tube of the hot water heater without the descaler.

- After 13 months, hot water heater #1, with only moderately hard water but *no descaler*, shows limescale completely covering the water supply line
- After 13 months, hot water heater #2 with precisely the same water but *with a Home Water Plant descaler* shows no limescale.

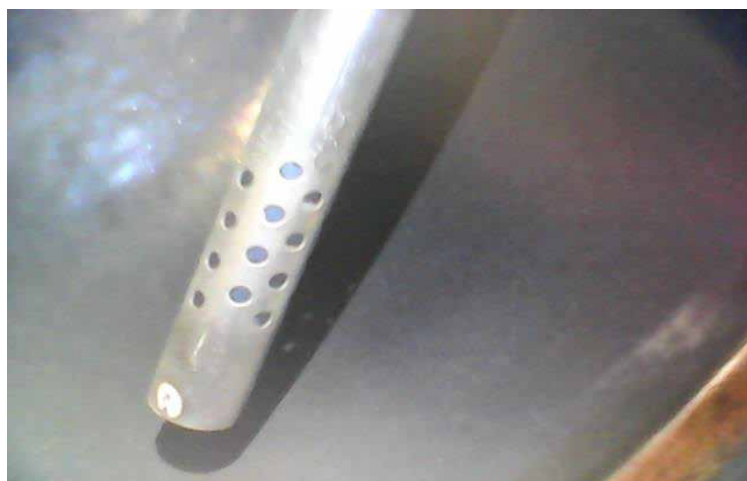
Water Supply Tube inside Hot Water Heater #2

WITH DESCALER

All one can see is the shiny metal surface of the water supply tube in the hot water heater with the descaler. There is no white limescale encrustation.

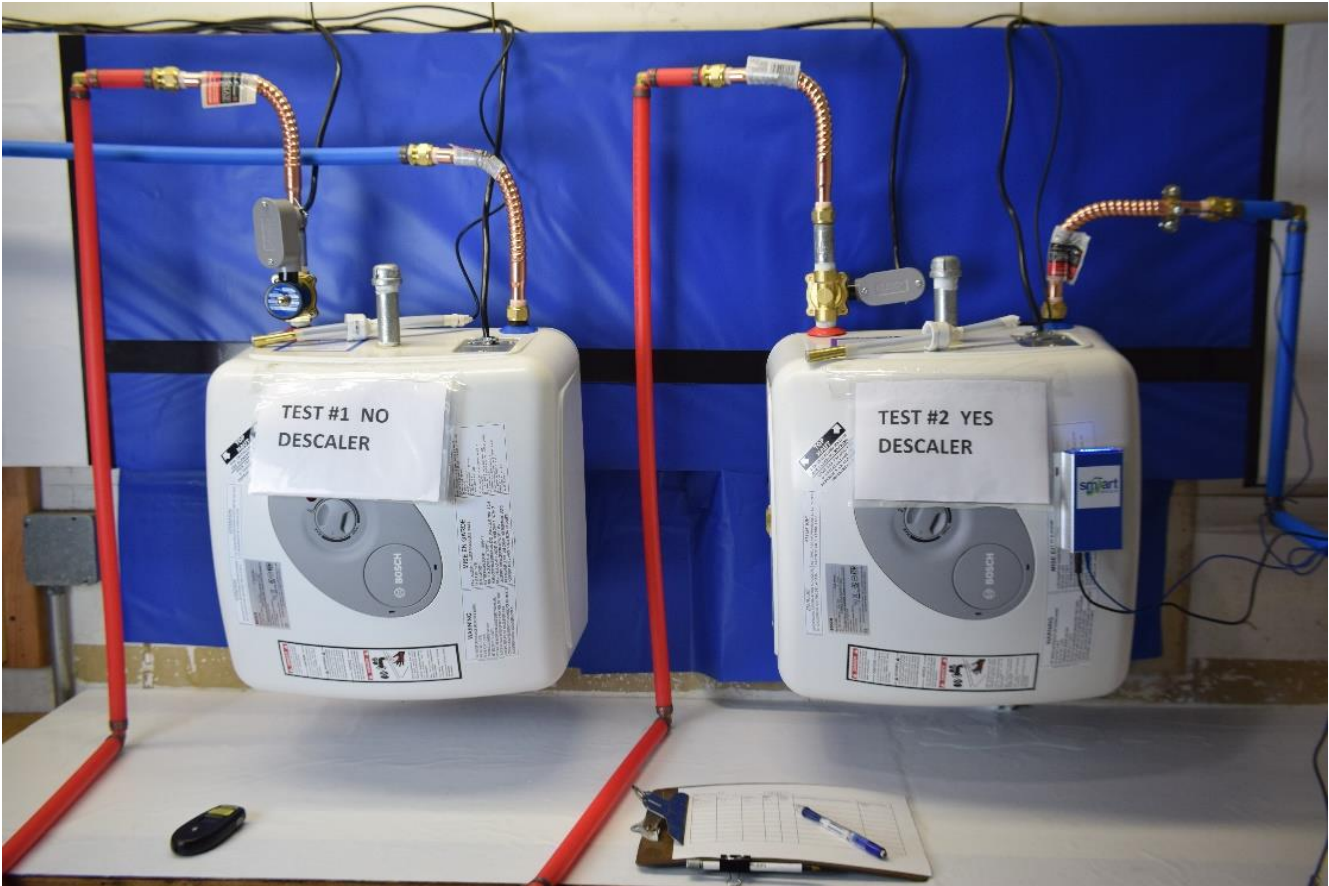
Picture of set up as of December 5, 2017

Two new 7 gallon Bosch hot water tanks were set up and supplied with moderately hard water from the city of Auburn at Aquametrics. For experiment 1 (with no descaler), the water runs into the hot water heater via a direct connection to plumbing in the Aquametrics building. For experiment 2 (with the descaler), the water flows into the hot water heater from a 50 gallon drum that holds identically sourced water. Water flows into and out of each hot water tank for a 1 minute interval, hourly. There is a pipe camera for each experiment. On December 5, 2017, a pipe camera was placed near the heating element near the bottom of each hot water heater. Placement of the pipe camera lens and lighting were optimized in each tank. Still pictures and video/audio were taken and saved to files in appropriate folders. In addition, video and audio were shot of each set-up using the following scripts:
